ABBREVIATED PRELIMINARY ASSESSMENT CHECKLIST

Site Name: 738 Upper Mountain Road

PROJECT:
738 Upper Mountain Road

Site Location Map
738 Upper Mountain Road
Lewiston, NY

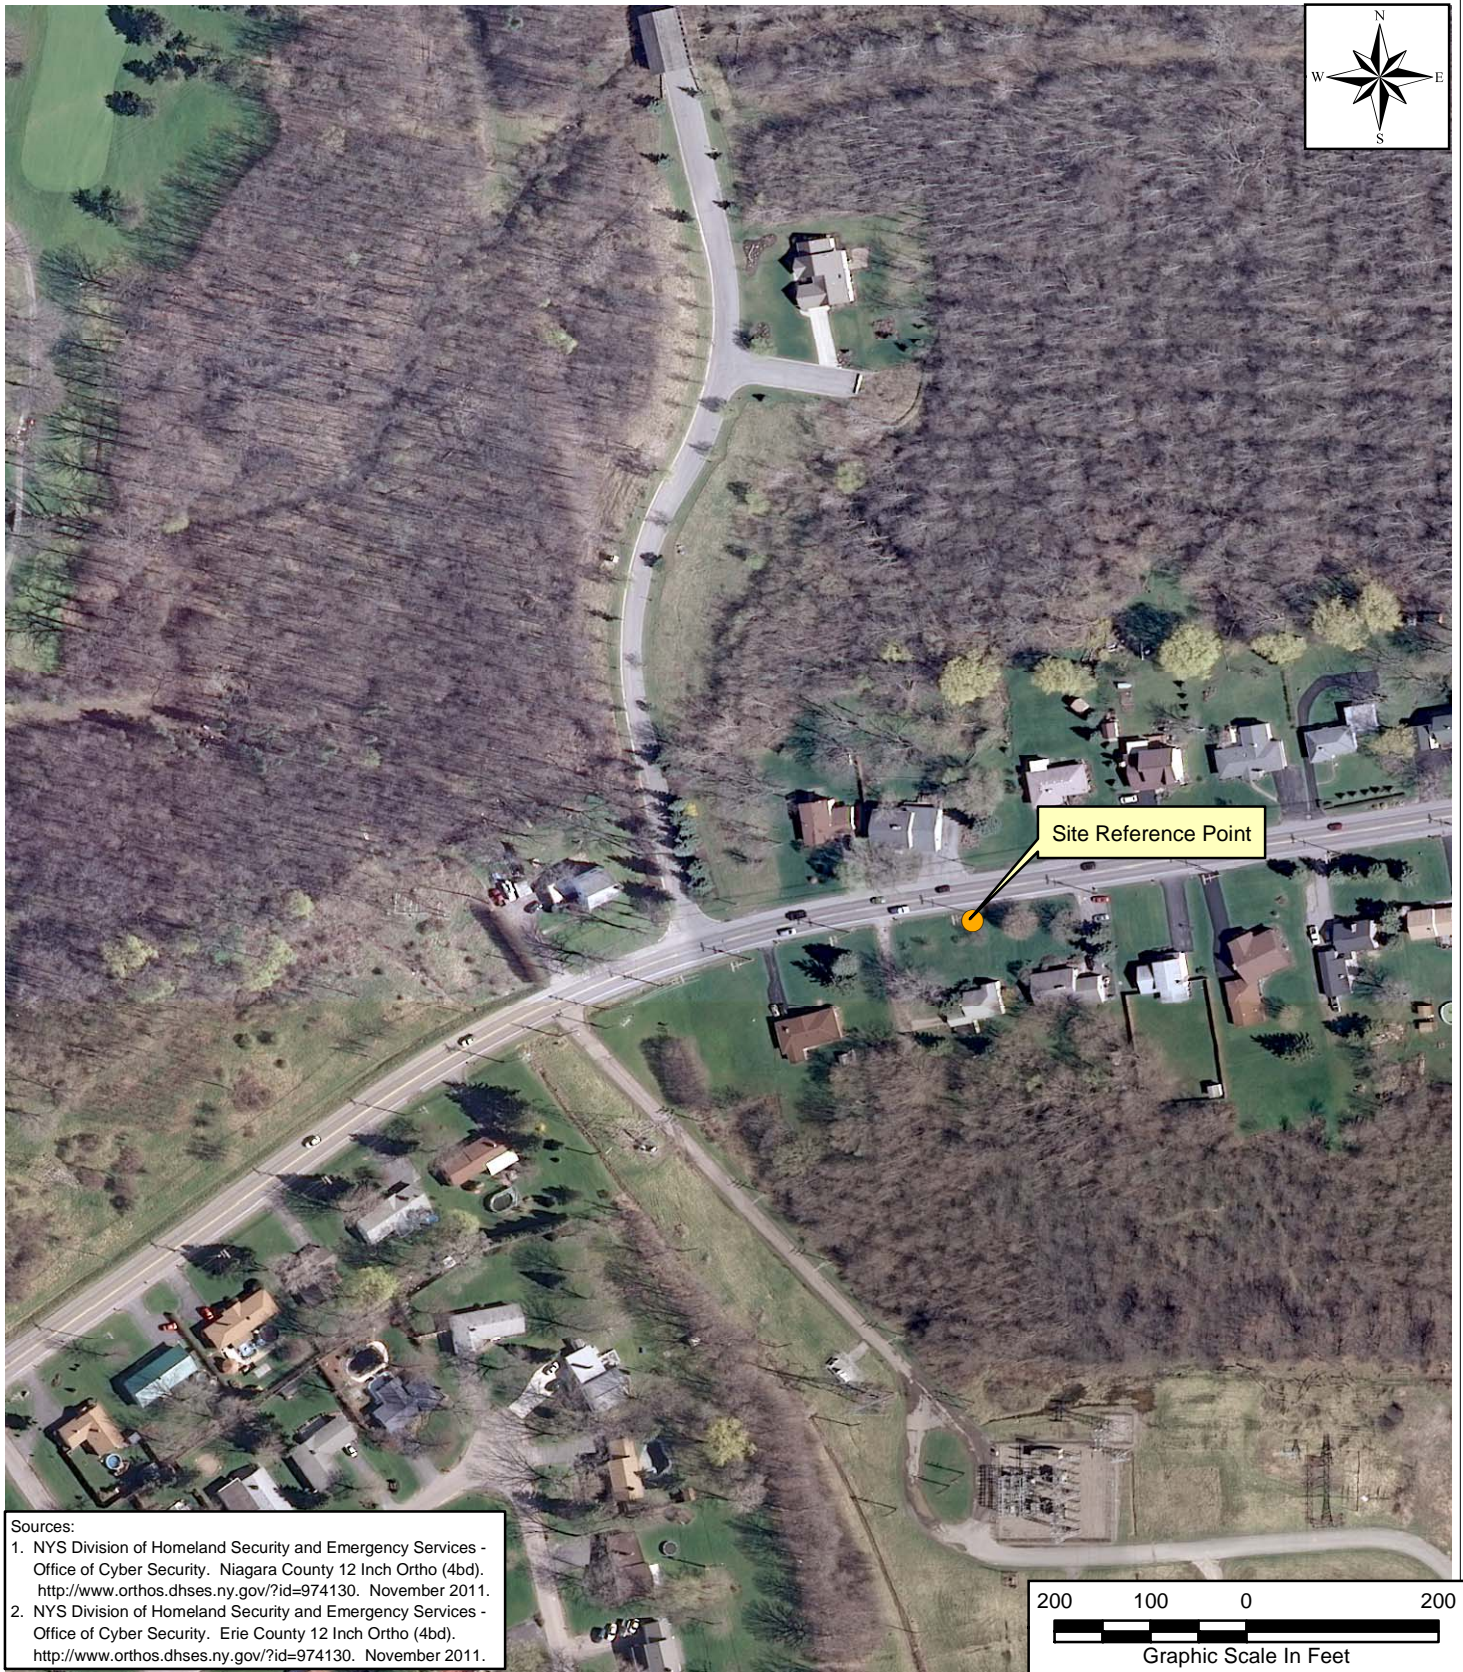
FIGURE #:

**Gamma Radiation
Screening Results
(Counts per Minute)**

- Less Than 9,000
- 9,001 - 18,000
- 18,001 - 30,000
- 30,001 - 100,000
- 100,001 - 300,000
- Greater Than 300,000

1. Background gamma radiation screening level is approximately 9,000 CPM.
2. Gamma radiation screening was conducted on 09/10/2013.

Gamma Radiation Screening Results Map
738 Upper Mountain Road
Lewiston, NY

During a September 10, 2013 reconnaissance, Weston Solutions, Inc. (WESTON[®]) performed a gamma radiation screening on site. Elevated gamma readings were observed toward the end of the driveway close to the road, in an approximately 45-foot by 45-foot gravel area. The readings in the area of elevated gamma radiation ranged from greater than background levels (i.e., approximately 9,000 CPM) to greater than 300,000 CPM (i.e., readings greater than 35 times background gamma radiation). The majority of the driveway is gravel and showed no signs of discoloration as seen in Figure 3. Values greater than two times background are considered to be a likely indication that contaminated material is present at those locations. Other contributing factors should be considered in defining “significant”, which include contaminated soil depth, source, consistency of screening meter height, etc.
